MHT Number HO-662

Name and SHA No. Hipsley Mill Road over Cabin Branch/HO35
Location: Street/Road Name and Number: Hipsley Mill Road
City/Town: Annapolis Rock Vicinity x
County: Howard
Ownership:State_x_CountyMunicipalOther
This bridge projects over:RoadRailway_x_WaterLand
Is the bridge located within a designated district:yes_x_no
NR listed districtNR determined eligible districtlocally designatedother Name of District
Bridge Type:
Timber BridgeBeam BridgeTruss-CoveredTrestleTimber-and-Concrete
Stone Arch
Metal Truss
Movable BridgeSwingBascule Single Leaf_Bascule Multiple LeafVertical LiftRetractilePontoon
x Metal Girder x Rolled GirderRolled Girder Concrete EncasedPlate GirderPlate Girder Concrete Encased
Metal Suspension

MARYLAND INVENTORY OF HISTORIC BRIDGES HISTORIC BRIDGE INVENTORY MARYLAND STATE HIGHWAY ADMINISTRATION/ MARYLAND HISTORICAL TRUST

MHT No. <u>HO-662</u>

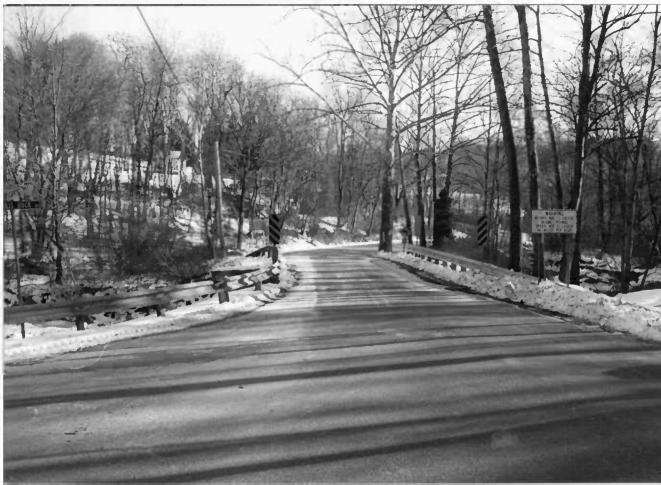
Inventory	#	Ha	agent .	6	6	2

Name HO35-HIPSLEY MILL RD OVER BRANCH
County/State HOWARD MD
Name of Photographer DAVID DIEHL
Date 2 95
Location of Negative SHA
Doublet of Hogazia
Description South Approach Looking
PORTHEAST
Number 13 of 2

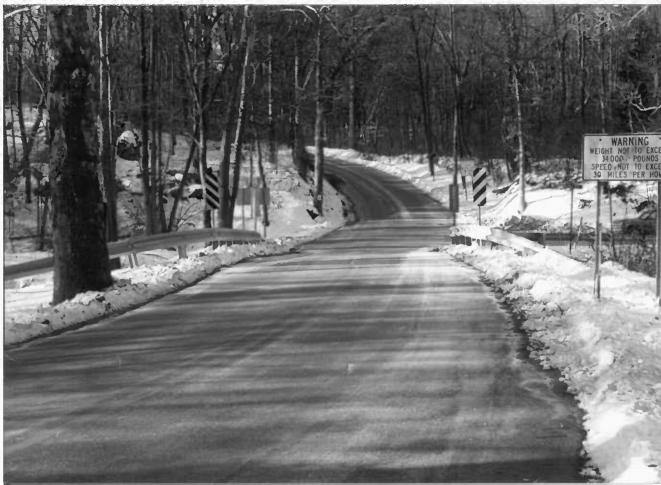
Number 19 of 3

Inventory # Ho-le(e2
Name HO35 - RIPSLEY MILL ROOVER CABIN BRANCH
County/State HOWARD MP
Name of Photographer DAVID OIE HL
Date 2 95
Location of Negative SHR
200
Description NORTH APPROACH LOOKING

SOUTHWEST

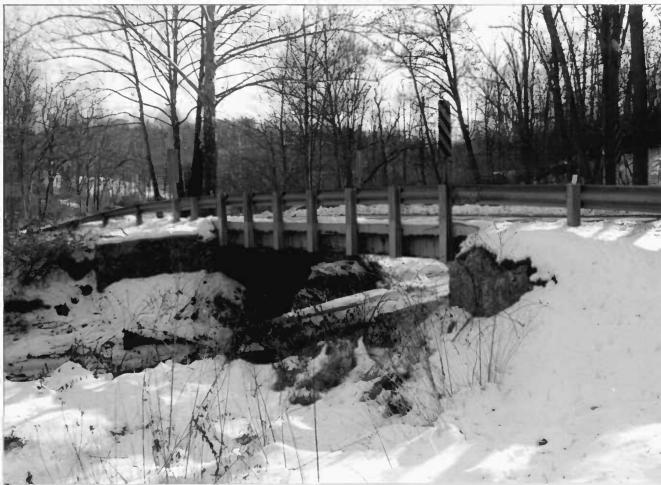
Inventory # <u>H0-662</u>

Name HO35-HIPSLEY MILL RO OVER (ABIN BRANCH County/State AOWARD IMD
Name of Photographer DAVID DIENL
Date 2 95
Location of Negative SHR
Description WEST ELEVATION LOOKING
EAST
4
Number of 3
